Prüfbericht-Nr.: <i>Test Report No.:</i>	21208413.016_Rev2	Auftrags-Nr.: <i>Order No.:</i>	21237994	Seite 1 von 8 Page 1 of 8	
Kunden-Referenz-Nr.: <i>Client Reference No.:</i>	223874	Auftragsdatum: <i>Order date:</i>	26.10.2016		
Auftraggeber: <i>Client:</i>	LG Electronics Inc. 168, Suchul-daero, Gumi-si, Gyeongsangbuk-do, 39368, Korea				
Prüfgegenstand: <i>Test item:</i>	Crystalline PV modules				
Bezeichnung / Typ-Nr.: <i>Identification / Type No.:</i>	LG350S2W-A5				
Auftrags-Inhalt: <i>Order content:</i>	Ammonia corrosion testing of photovoltaic (PV) modules				
Prüfgrundlage: <i>Test specification:</i>	IEC 62716:2013 Photovoltaic (PV) modules - Ammonia corrosion testing				
Wareneingangsdatum: <i>Date of receipt:</i>	25.10.2016	Detaillierte Fotodokumentation siehe Anlage zu diesem Bericht Detailed photo documentation see appendix to this report			
Prüfmuster-Nr.: <i>Test sample No.:</i>	HV2016003700,HV201600370 1,HV2016003702

LG350S2W-A5

According to the inquiry the resistance to ammonia of photovoltaic (PV) modules should be assessed in accordance with **IEC 62716:2013**. For the qualification of the modules to this test initial and final control measurements were perform

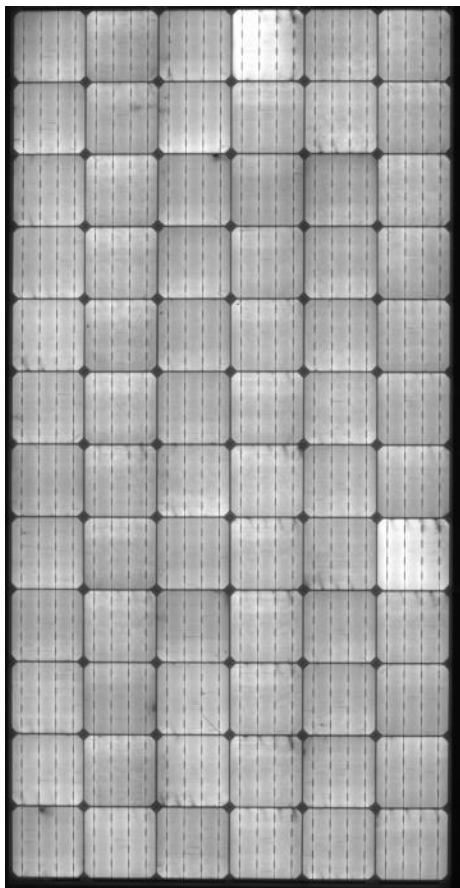
Fig. 1: HV2016003701

6.2 c)	Visual inspection (Initial)		
Sample No.	Nature and position of initial findings		—
HV2016003700	No visual defects		P
HV2016003701	No visual defects		P
HV2016003702	No visual defects		P
Supplementary information: -

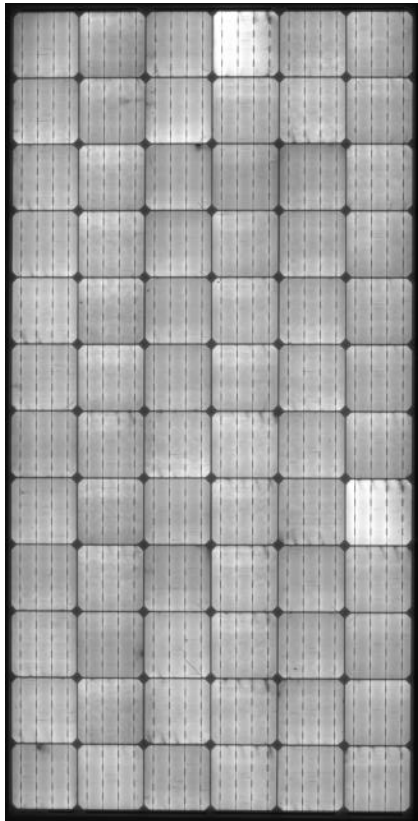
Fig. 3: HV2016003701

9.2 c)	Visual inspection after ammonia corrosion test		
Sample No.	Nature and position of findings		—
HV2016003701	No visual defects		P
HV2016003702	No visual defects		P
Supplementary information: -

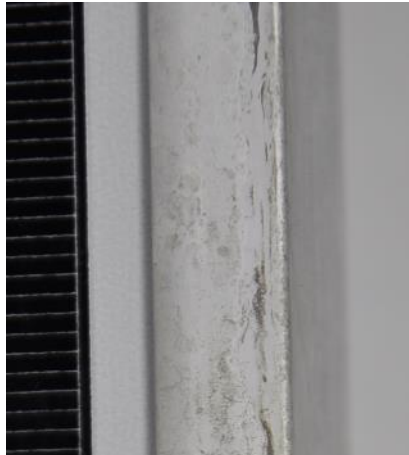
Fig. 5: detailed right side of frame after ammonia corrosion test

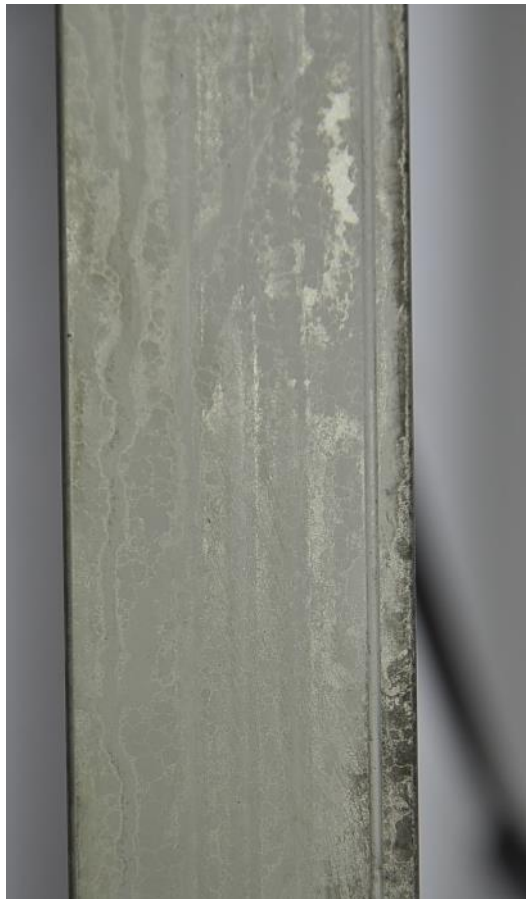
Fig. 6: detailed side view to frame after ammonia corrosion test
